Toyota Land Cruiser Model year: 1998 - 2000

Condenser fan runs permanently

Bulletin

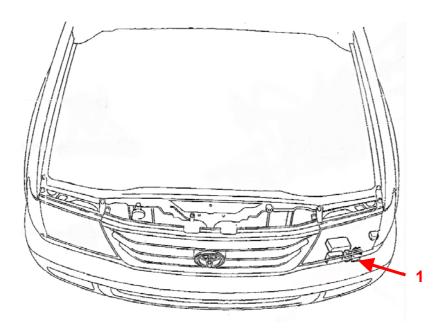
If in the case of the above-mentioned vehicles the condenser fan should continue running after the ignition has been switched off, one possible cause is a faulty condenser fan relay. In the case of vehicles up to chassis no.: JT3HT05J#Y0114880 corrosion on the relay connector can lead to the condenser fan remaining on permanently. To remedy the problem, connection contacts should be cleaned and protected from further corrosion. If necessary the relay and/or connector have to be replaced. There is a repair set available from the vehicle manufacturer for this purpose. The relay is in the front part of the engine compartment (drawing, pos. 1).
