Airlift set

Venting, filling and leak test on the coolant system

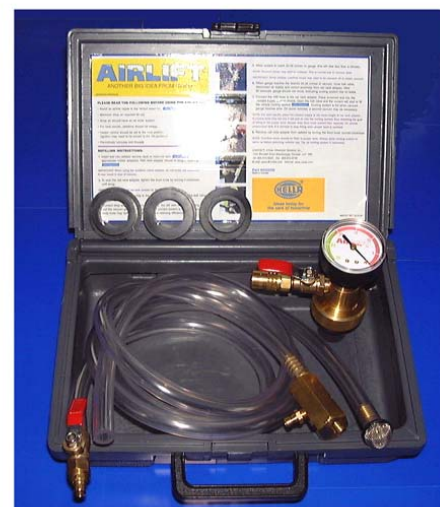
The *Behr Hella Service Airlift* system remedies the problem. Part no.: 8PE 351 225. The system is used to eliminate air bubbles, look for leaky spots and facilitate quick refilling of the cooling system. Airlift is connected to the radiator or the expansion vessel using the enclosed adapter. Next you connect a compressed air hose such as the one you use to operate pneumatic tools. The cooling system is evacuated via a special valve, and a high vacuum is created. Subsequently, the enclosed suction hose is attached and the fresh coolant filled from a clean coolant container (bucket, can). With the aid of the manometer which measures the vacuum at the Airlift, the air-tightness of the complete system can be checked.
