VW Golf 4 TDI

Speedometer failure due to faulty wiring harness

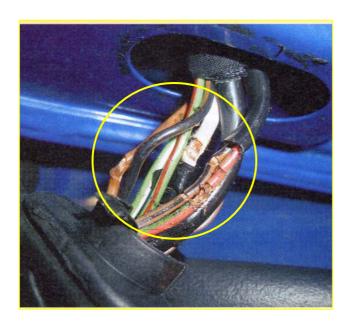
If the speedometer in the above-mentioned vehicle should suddenly fail and the speed transmitter fuse blow, the cause could be in the area of the cable duct on the tailgate. In a specific case, the fuse for the speed transmitter blew repeatedly after a certain period. Further tests showed that the fuse for the reversing lamps was also faulty, and the cause for this was not the reversing switch. The duct for the wiring harness on the tailgate was subsequently checked and it was found that the insulation of several cables was damaged (see photo), so causing a short circuit. Once the wiring harness had been repaired the problems did not recur.
