VW Golf IV TDI

Bulb replacement Main headlamp, left

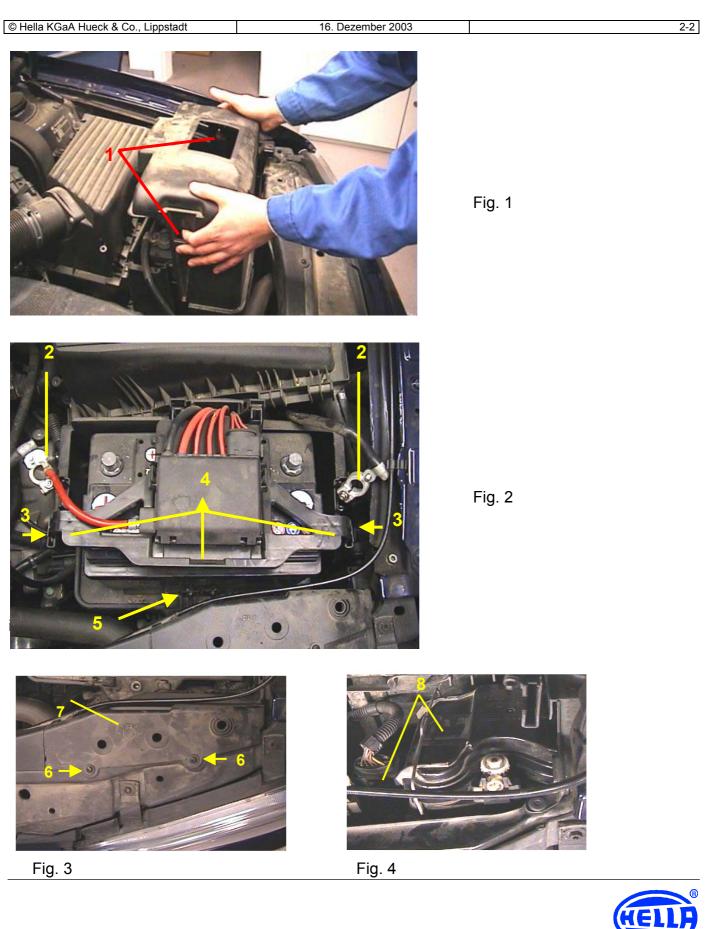
- Note radio code
- Remove the battery cover (press unlocking mechanism on the right and left, Fig. 1 / Pos. 1)
- Disconnect negative and positive terminals from the battery (Fig. 2 / Pos. 2)
- Press the snap-in attachments on the left and right of the plastic bridge, Fig. 2 / Pos. 3
- Hinge the plastic bridge including electrical connections upwards (Fig. 2 / Pos. 4)
- Remove the battery holder (Fig. 2 / Pos. 5)
- Remove the battery
- Remove the 2 screws (Fig. 3 / Pos. 6) for the cover (Fig. 3 / Pos. 7) and pull the cover upwards and out
- Remove the cover cap (release clamp) from the headlamp (Fig. 4 / Pos. 8)
- Carefully remove the plug from the bulb
- Remove the bulb
