# LuK Clutch Academy

## Caddy 1.6 TDi

These instructions are for a 2011 Volkswagen Caddy fitted with a 1.6 TDi common rail CAYD engine. The Caddy, introduced to Europe in 1982, is currently in its third generation. This model Caddy is based on a Volkswagen Touran with a Golf Mk 5 front suspension. The Volkswagen Caddy shares the same platform as other VAG models with a transverse engine and gearbox, so there is a good chance this will look quite familiar when the bonnet is raised.

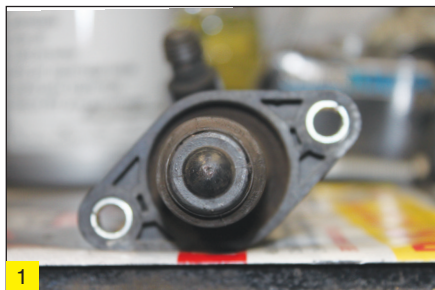
1

Disconnect the gear change cables from the selector linkage, remove the three bolts from the gear cable support bracket and stow in the bulkhead area. Remove the plastic quadrant from the selector mechanism by removing the retaining clip, which will ensure the quadrant is not damaged during the gearbox removal and installation. Take off the centre nut from the selector mechanism and remove the gear change weight. Now remove the clutch slave cylinder assembly, inspect the slave cylinder for any fluid leaks or wear to contact areas. We found wear on the end of the slave cylinder push rod (figure 1), so a clutch slave cylinder replacement was advised.

Ensure the gearbox alignment dowels are still installed correctly in the engine block and then refit the gearbox. Once secured in position, the free play on the release arm can be felt, to ensure correct fitment before full installation is carried out in reverse order of removal. A new clutch slave cylinder was fitted at this point, and the clutch hydraulic system was gravity bled. Torque all bolts to the manufacturer's specifications, check and top up the gearbox oil level as required, and also ensure all electrical items are reset after the battery has been connected. Finally, carry out a full road test to ensure clutch and gearbox operation are correct.

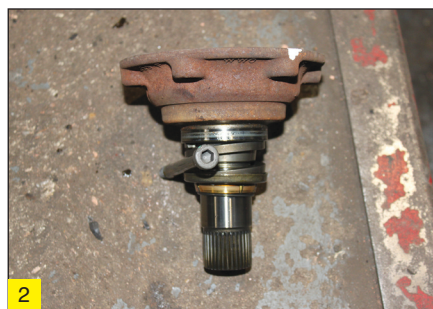
2

underside and remove the engine under tray. Remove the gearbox pendulum mounting, and take out the six driveshaft flange retaining bolts from both driveshafts. Disconnect the ball joints from the bottom suspension arms and release, there will now be enough clearance to move the driveshafts away from the gearbox and secure to aid gearbox removal. The O/S gearbox output flange can now be removed by taking out the centre bolt. Be careful when removing the flange as some gearbox oil can run out (figure 2).

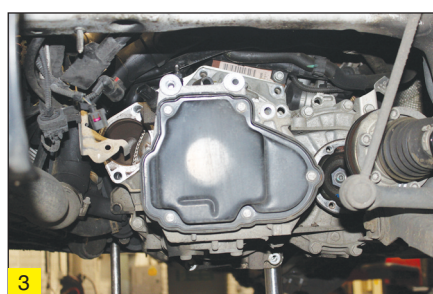
3

Remove the bottom bell housing bolts, bottom starter motor bolt and the starter motor, lower the ramp and support the engine with an engine beam or support frame. Release the gearbox mounting and then lower the engine on a beam to a position that the gearbox can be removed. Raise the vehicle and support the gearbox with a transmission jack and the gearbox mounting bracket bolts can now be accessed from the left front wheel arch area. Remove the three bolts and the bracket (figure 3), and take out the final bell housing bolts and then remove the
