LuK Clutch Academy

Audi TT 2.0TDi Quattro

The Audi TT, launched in 1998, has proved to be a popular two door sports car on Irish roads. The third generation of TT was launched in 2014. The LuK technical team takes a closer look at the 2.0TDi Quattro clutch and flywheel replacement and offers a few handy hints that should prove useful to any independent aftermarket workshop looking to undertake the repair.

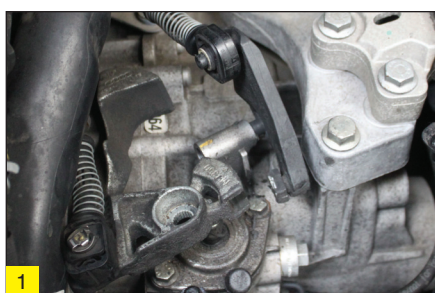
Install the engine support beam, applying slight tension to hold the engine and gearbox. Remove the three top gearbox mount bolts and mounting bracket, as this restricts the gear link cables from being removed (fig 1).

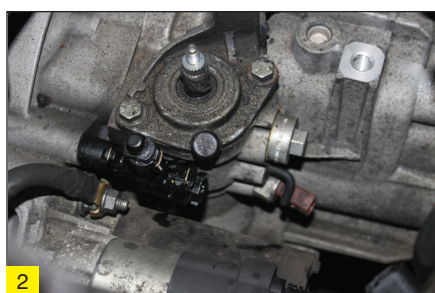
Disconnect the reverse light switch. Disconnect the clutch slave cylinder hydraulic pipe, and blank, and stow safely (fig 2). Remove the starter motor bolts, one of which holds in place the earth lead which will need to be stowed, and then remove the starter motor carefully. Remove the top two bell housing bolts and then raise the vehicle. Disconnect the oil level sensor switch. Drain the transmission oil.

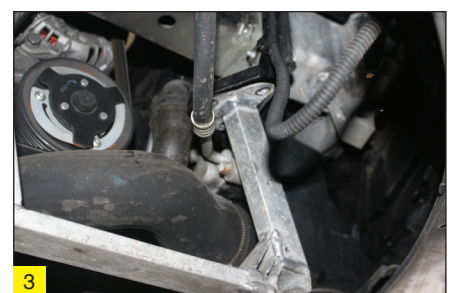
Remove the engine under tray liner and the front wheel arch liners from both sides. Remove the under tray framework, looking out for the difficult bolts blocked by the air

conditioning hose, but they are accessible with no need to remove any pipework (fig 3). Disconnect the drive shaft nut and bolt configuration from the axle drive.
