Renault Modus 1.4P

This month, REPERT's Alistair Mason replaces the clutch on a 2005 Renault Modus, which was fitted with a 1.4 (K4J770) petrol engine, had covered more than 60,000 miles and suffered from clutch judder.

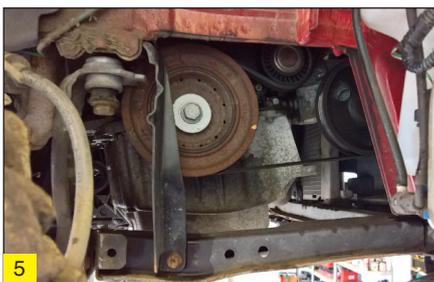
Remove both front wheel arch liners, remove both front hub nuts and both bottom ball joint pinch bolts. Disconnect the ball joints from the hub assembly by levering down the lower suspension arms. Swivel out the hub assemblies, and remove the driveshafts from the hub assemblies, which will allow the N/S/F inner driveshaft joint to pull clear of the gearbox. The centre bearing needs to be released from its carrier, and the driveshaft can then be removed. Remove the supporting brackets from the front sub-frame and the vehicle body on both sides (Fig 1).

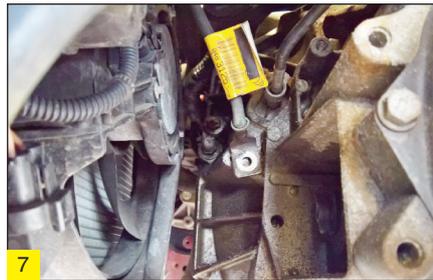
Disconnect the earth cable (Fig 2), and

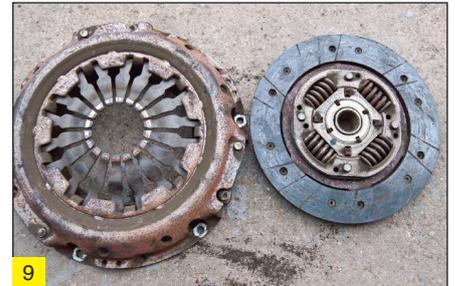
The clutch can then be removed from the flywheel (Fig 3). The root cause of the clutch judder was identified as the clutch system being rusty and dry, with no lubrication, thus not giving a smooth release. The clutch plate had also reached the end of its service life, as the lining was nearly level with the metal rivets. The flywheel was inspected for heat and stress cracks, with no evidence of either.

Subsequently, clean the flywheel face with Emory cloth to remove the surface glaze, and then clean the flywheel and back of the engine to remove the old clutch dust with brake and clutch dust cleaner.

Fit the new clutch to the flywheel using a universal clutch alignment tool to clamp the clutch plate to the pressure plate/cover in a central position.

To ensure the clutch plate is fitted correctly, 'Gearbox Side' or 'Getriebe Seite' is marked on one side near the centre of the clutch plate. When installing the clutch, tighten the bolts evenly and sequentially, so to not distort the new clutch, and torque to the manufacturer's specification.
