### Issue no. 03/2018: Damaged oil filter paper

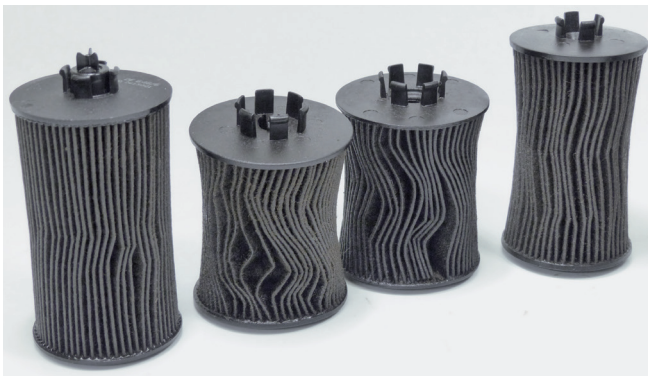
- The first and most common reason is noncompliance with proper maintenance and replacement intervals. The oil filter is worked too hard, reaches its maximum absorption limit, and collapses.
- The second possibility is continued operation at high engine temperatures. This makes the filter paper age faster and the impregnation layer become brittle. The result: the cellulose fibers break down, the paper tears, and the filter disintegrates.

Figure 1: Collapsed oil filter inserts

**IMPORTANT:** Besides complying with the manufacturer's specifications, oil and filter changes should always be adapted to suit the individual driving profile! The use of high-quality engine oil can also reduce the load on the oil filter significantly.

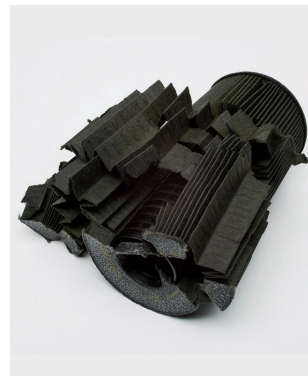
Figure 2: Disintegrated oil filter insert

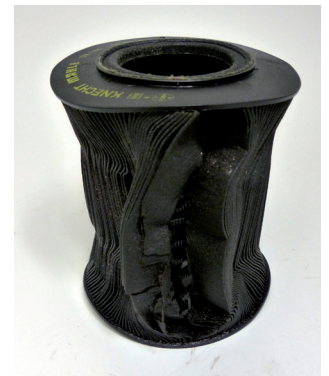
Figure 3: Oil filter insert deformed/torn as a result of overheating
