Air mass sensors: Note assignment!

Vehicle	Product	PIERBURG No.
BMW, Fiat; Opel; Volvo	Air mass sensor	7.22701.04/.05.0/.08.011.0; 7.22684.07.011.0

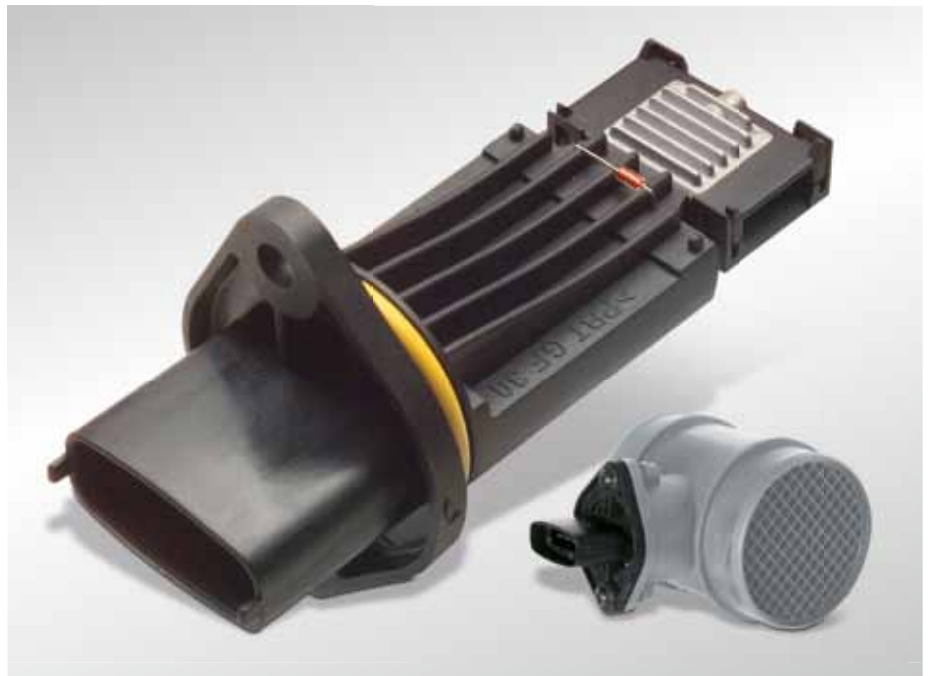
Air mass sensor plug-in probes look extremely similar to one another. However, the integrated electronic modules contain different characteristic curves adapted for the specific engine type.

Air mass sensor (plug-in probe)

! When ordering, make sure that you specify the exact engine type and any possible delineation by chassis number, engine code and year of manufacture.
