Electric EGR valves

Matching to the engine controller is required

Vehicle	Product	PIERBURG No.	O.E. No.*
various VW, Seat, Skoda, Audi	Electric EGR valve	7.22574.11.0; 7.28070.02.0; 7.22785.11.0/.12.0/.13.0/.14.0 7.28248.16.0	see catalogue/TecDoc CD

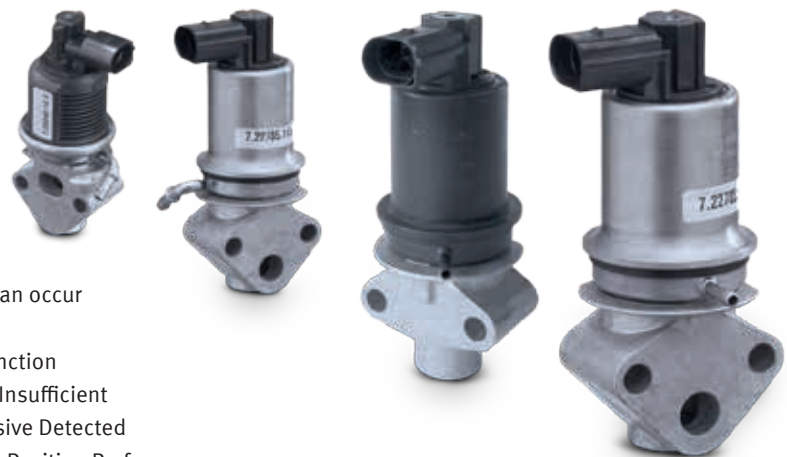
Different electric EGR valves

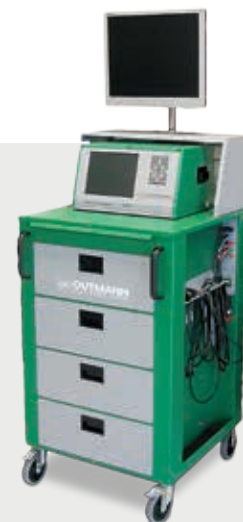
Basic adjustment	
Adaption throttle body control unit	MO
Check Lambda Converting Bank 1	MO
Adaption EGR valve	
Reset gear data	GE

*Output for EGR valve matching
(Gutmann engine tester, for example)*

The electric EGR valve must be adapted to the engine controller!

This is done by selecting a special programme of the engine tester (“default setting”, for example).
