Leaking water pumps caused by incorrect coolant

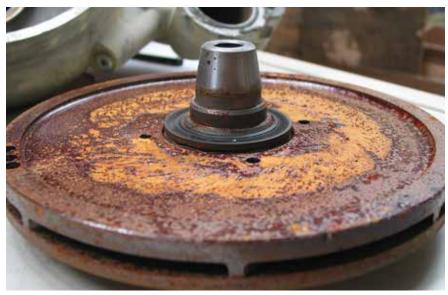
Primarily, corroded solid particles, which come off the surface of the cooling system, destroy the mechanical face seals of the water pumps. The main cause of this corrosion inside the cooling system is insufficient corrosion protection from the coolant.

Corroded impellers

Destroyed mechanical face seal - the sliding surface was corroded by foreign particles

Only use the coolant approved by the manufacturer for mixing the coolant. Avoid water with a high hardness level (>20°dH) or water from sea water desalination plants.

Ensure that the coolant is always mixed in a separate container outside the cooling system.

For sufficient and outstanding corrosion protection all year round, the mix ratio of coolant and water is important for ensuring the proper functioning and service life of the water pump. For safety reasons, we recommend a mix ratio of 50:50.
