Secondary-air system

Design, components, trouble-shooting

Vehicle	Product
All vehicles with spark-ignition engine and secondary-air system	Secondary-air valve, secondary-air pump, solenoid switching valve

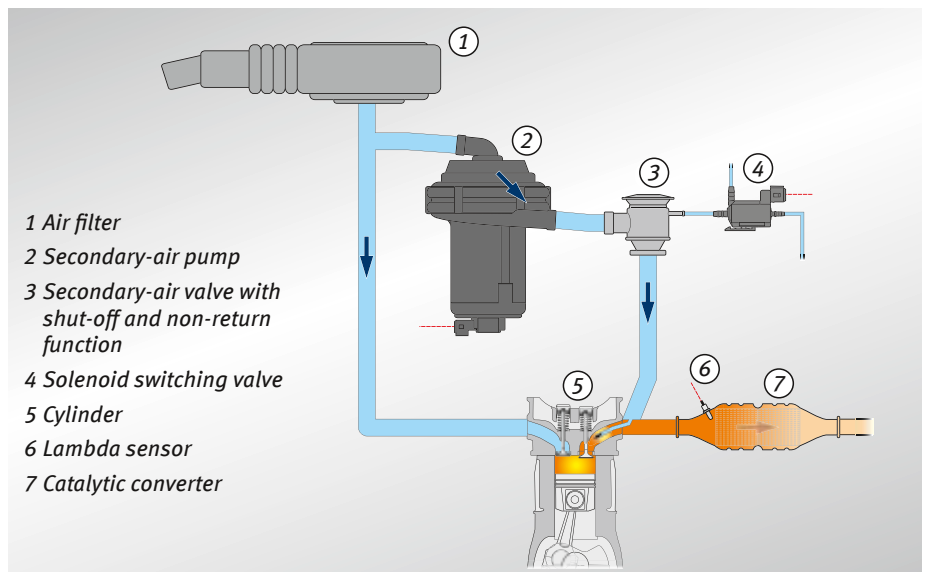
Block diagram of secondary-air system (pneumatically actuated)

Until the catalytic converter reaches operating temperature and Lambda control action starts to take effect, large quantities of carbon monoxide and unburnt hydrocarbons are produced. To reduce the level of these pollutants, ambient air with a high oxygen content (“secondary-air”) is injected into the exhaust manifold directly downstream of the exhaust valves during the cold starting phase. This results in post-oxidation (“afterburning”) of the pollutants to form carbon dioxide and water. The heat generated in this process additionally warms the catalytic converter and speeds up the onset of Lambda control action.

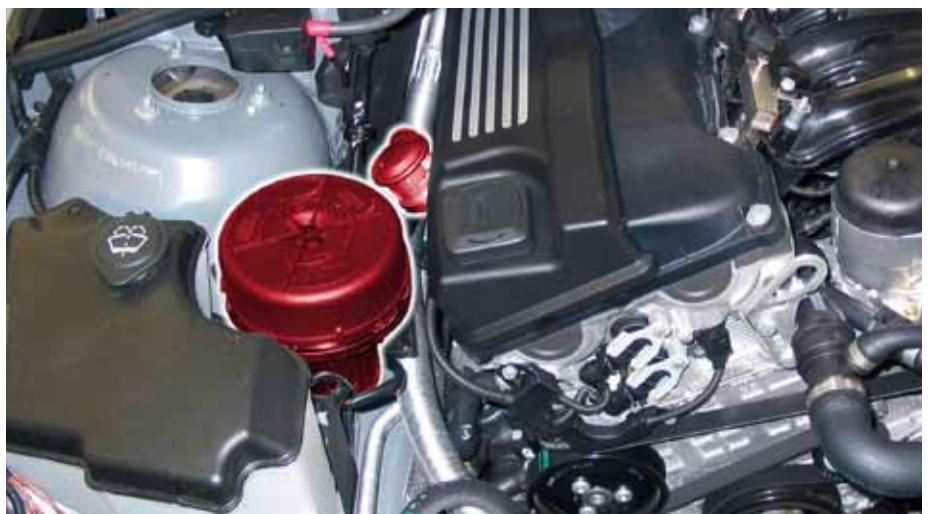
Secondary-air valve and secondary-air pump in BMW E46 (highlighted)

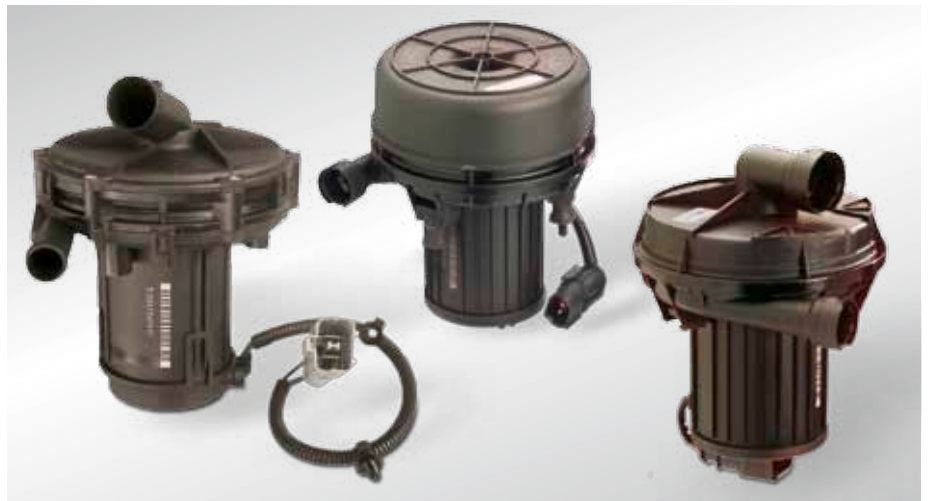
Various 1st and 2nd generation secondary-air pumps

The secondary-air pump draws in ambient air and injects it into the exhaust manifold downstream of the exhaust valves. There is a separate integrated air filter if the air is not drawn in from the intake system but rather directly from the engine compartment.

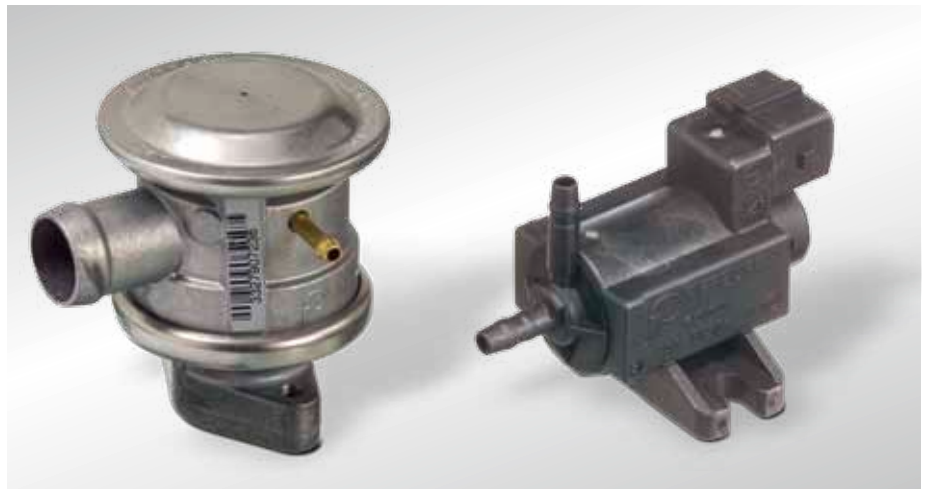
Vacuum-controlled valve with shut-off and non-return function (since approx. 1995) and solenoid switching valve

Secondary-air valves are either actuated by a vacuum controlled by a solenoid switching valve or open in response to the pressure of the secondary-air pump.

With more recent generations, the shut-off and non-return functions are combined in one single "secondary-air valve".

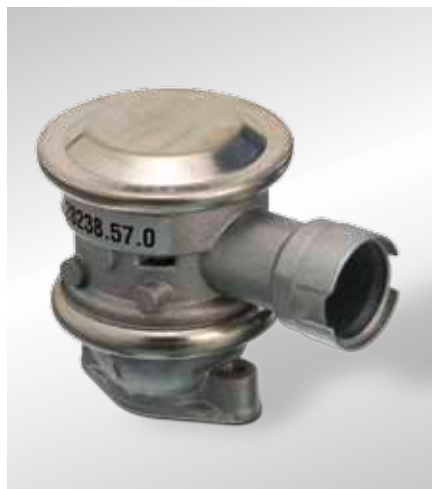
Pressure-controlled valve with shut-off and non-return function (since approx. 1998)

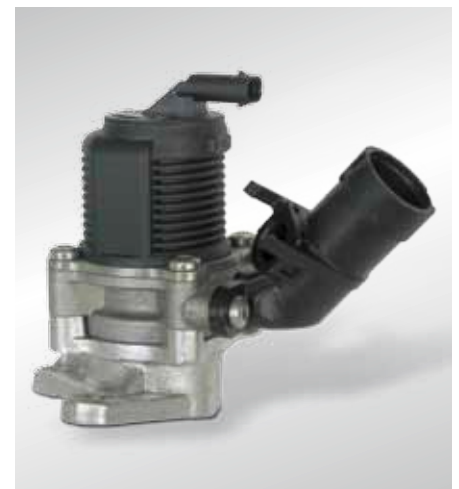
Solenoid Secondary-air valve (since approx. 2007)

The latest development is the solenoid secondary-air valve, featuring shorter opening and closing times than pneumatically actuated valves. Thanks to higher actuating forces, this type of valve is less susceptible to clogging by soot or dirt.

Solenoid secondary-air valves may be equipped with an integrated pressure sensor for on-board diagnosis (OBD) monitoring.

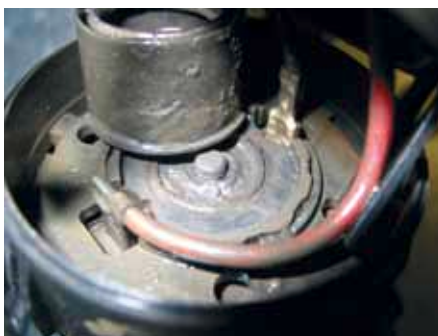
In most of these cases, a defective non-return valve or incorrect actuation of the secondary-air valve has led to exhaust gas condensate ingressing into and damaging the secondary-air pump.

Corrosive exhaust gas condensate in the drive motor of a secondary-air pump

- The secondary-air pump must be replaced if it does not run or makes a scraping, whistling or scratching noise during operation.
- In such cases, the other secondary-air system components should also be checked.
- Check for contamination of the engine air filter.

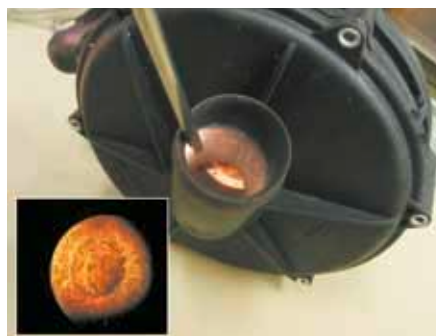
View of the corroded inlet of a secondary-air pump

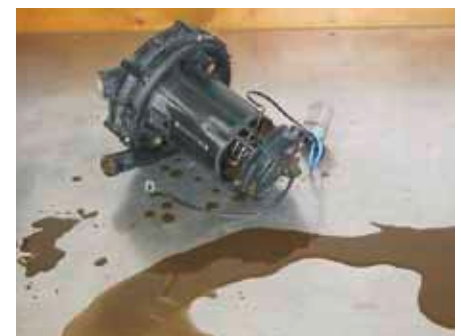
Liquid exhaust gas condensate from a secondary-air pump

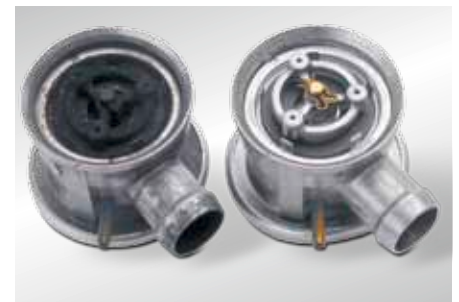
An open secondary-air valve can lead to biasing of the Lambda probe signal as being “too lean”.

Open secondary-air valve
 left: damage caused by exhaust gas condensate
 right: as-new condition

- The secondary-air valve must be replaced if it does not open on applying vacuum.
- If the secondary-air valve opens on applying vacuum, the solenoid actuation valve (solenoid switching valve) and the vacuum hoses must be checked.
- The secondary-air valve diaphragm is leaking if the vacuum applied with the vacuum hand pump decreases.
- Deposits on the side facing the secondary-air pump (check with finger, refer to adjacent illustration) are an indication of non-return valve leakage.
- To check, unfasten the connecting hose between the secondary-air pump and secondary-air valve.

In this case, the secondary-air pump may already have suffered damage: Check and if necessary replace the secondary-air pump.

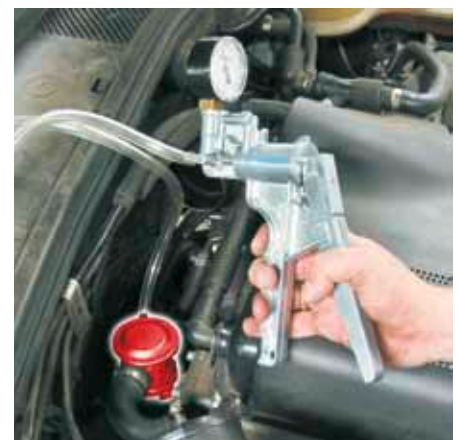
Following removal, operation of a vacuum-controlled secondary-air valve can be checked using a vacuum hand pump:

Checking a secondary-air valve with a vacuum hand pump

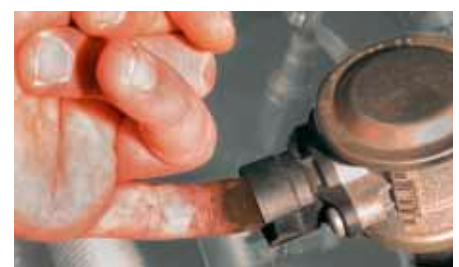
Finger check at secondary-air valve in BMW 520i (highlighted)
 If deposits are found on this end, the non-return valve is leaking and must be replaced.

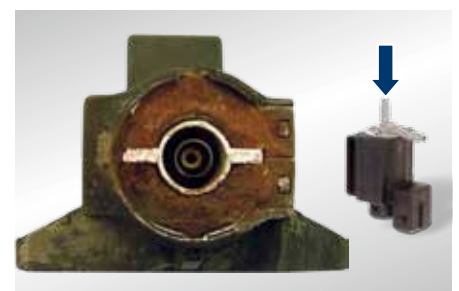
Corroded solenoid switching valve (open)

- A vacuum hand pump can be used to check for opening and leakage.
- During secondary-air injection, electrical system voltage must be applied to the connector of the solenoid switching valve. If not, an electrical fault has occurred which must be localised with the help of a circuit diagram.
