Alistair Mason, Schaeffler

# Best Practice - always replace the CSC

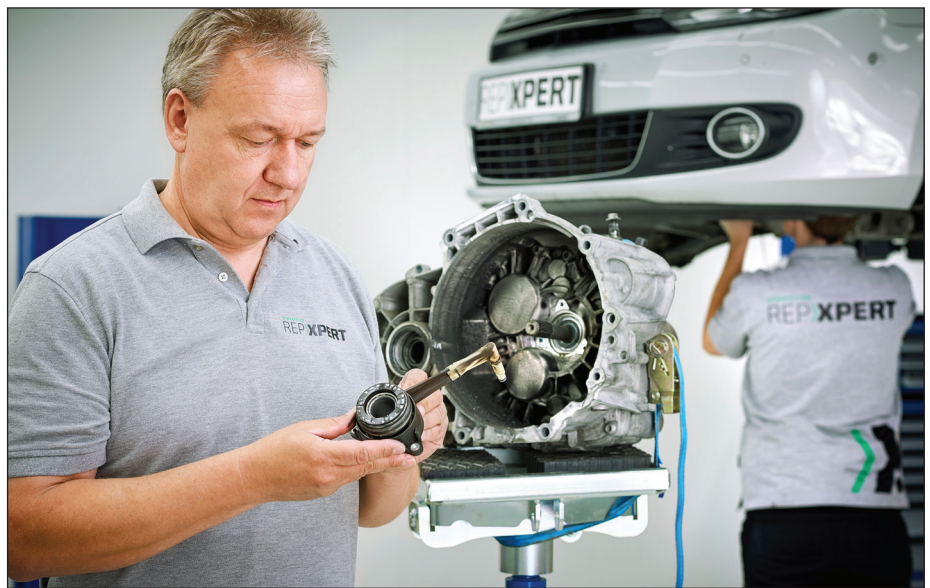
REXPERT Trainer Ralf Kuhlmeiy recommends to always replace the CSC when servicing a clutch
