Wheel fastening

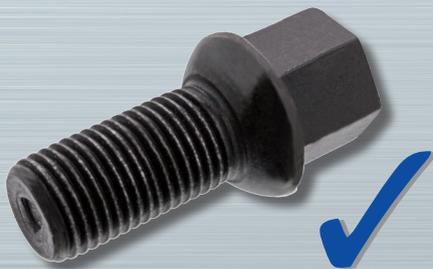
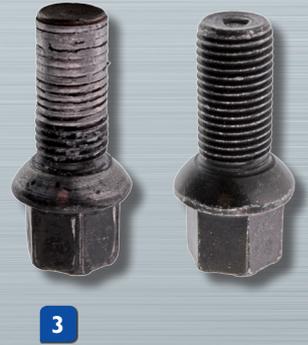
The friction value increases enormously in the case of rusted, dirty or damaged wheel fastenings and the result here, of course, is a drop in the pretensioning force (see Figs. 1 and 2).

Look for damage to the wheel fastening before each tightening procedure! It is advisable to replace the wheel fastening in the event of rust and any plastic deformations. The wheel hub should also be replaced if its thread is damaged.

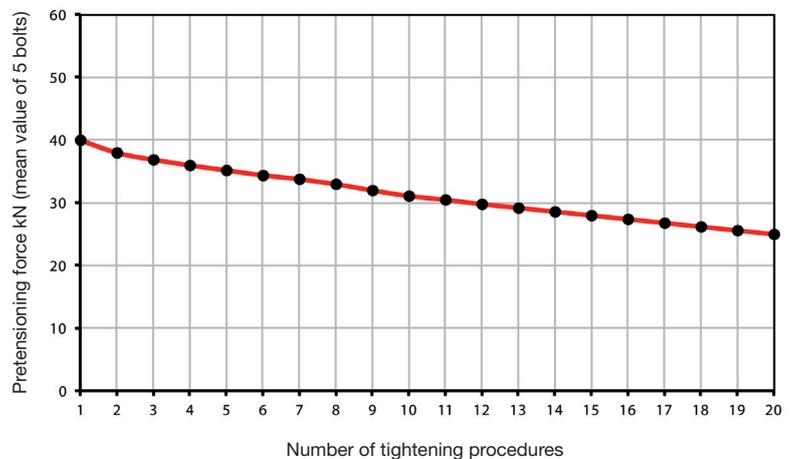
Pretensioning force curve

The curve of the pretensioning force changes when a wheel fastening is tightened several times. The surface of the thread is "damaged" each time it is tightened or loosened which increases the friction value in the thread and under the head. The torque wrench releases sooner than specified due to the increased friction value in the wheel fastening's thread. As a result, it is no longer possible to achieve the vehicle manufacturer's envisaged pretensioning force at the junction between wheel hub – rim – wheel fastening (see chart).
