Faulty release arm or guide sleeve

Part Number: 826362

For Vehicle: VW Polo 1.2 2005>

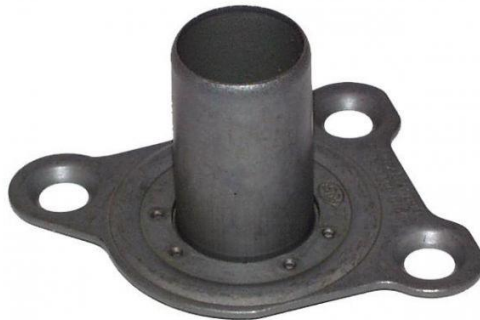
After further investigation Valeo technicians have identified that the clutch kit itself is not at fault and the symptoms seen is as a consequence of a worn release arm or guide sleeve.

Guide sleeve OE number 085141181 required.

- 1) While replacing the clutch check the release arm and the guide sleeve.
- 2) If there is any sign of them being worn or damaged replace either the release arm or the guide sleeve.
Valeo Service recommends replacing the guide tube with every clutch change.
