Window regulator initialisation failure

Part Number: 850902 and 850903

For Vehicle: Mini R56 2006-2013

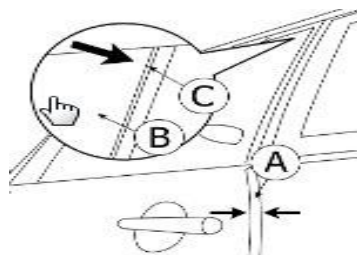
1. Close the window and partially close the door A, Check the position is correct as shown in B and C.

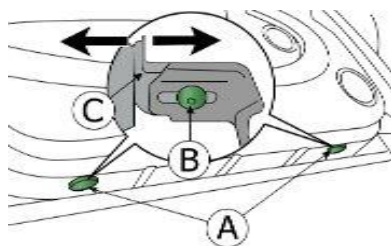
2. Remove the covers A, Loosen the bolts B, Adjust the power window mechanism C, Tighten the bolts B and refit the covers A.

3. Loosen the window glass retaining bolts. Adjust the glass upwards and towards the door front, tighten the bolts. After adjustment initialise the power windows then press and hold the power window open switch. Open the window fully press and hold the power window close switch then hold for 3 seconds.
