Valeo Pull type bearing with nylon guide collar

For Vehicle: With pull type clutch applications

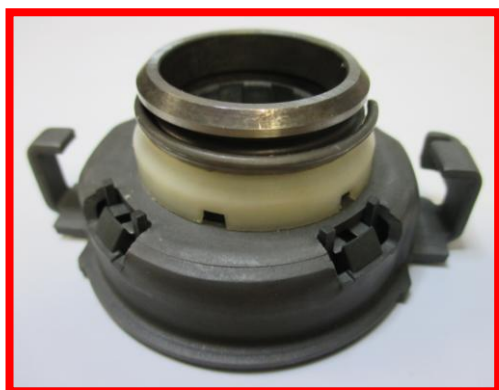
Bearing NOK: Guide collar is not compressing the circlip preventing smooth entry into the cover assembly.

Note: If the circlip is exposed, remove the circlip then the guide collar. Refit the circlip, compress the circlip into the recess and slide the guide collar over the circlip. **The circlip should lock into a recess at the front of the guide collar.**

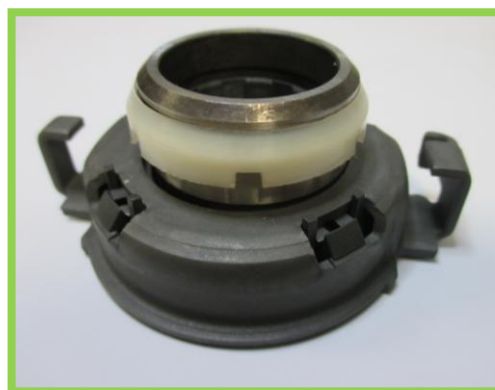
Bearing OK: Guide collar is compressing the circlip allowing smooth entry into the cover
