Ford Transit Spigot bearing checks

Part Number: 835000 / 826700, 835057 / 828372, 835060 / 828386, 826100, 826752, 828162

For Vehicle: Ford Transit 2.4d

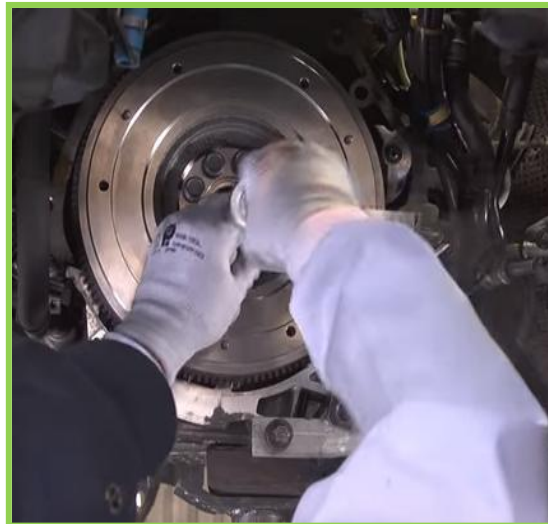
Check the spigot bearing before fitment of the new clutch and/or flywheel

After investigating the issue Valeo technicians have identified that the vibration is caused by an excessively worn input/first motion shaft spigot bearing and not the newly changed clutch/flywheel. Changing of the spigot bearing is recommended during every clutch change as if this is not performed the worn spigot bearing cannot provide adequate lateral support and this causes misalignment of the clutch driven plate which then results in judder upon take up of drive.
