Nothing is as good as good information

eXponentia's Steve Carter recounts troubleshooting faults on three very different cars with one common key to a successful repair; the availability of vehicle specific information.

Steve Carter, eXponentia

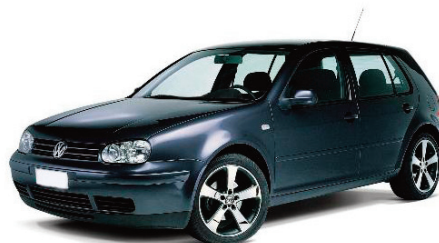
The first was a VW Golf Mk4. When the ignition was switched on, the driver information display showed a warning of low oil level; however this level was satisfactory on

starting the vehicle. The oil warning light would stay on when the engine was running, but only as an orange glow rather than red. Having received several of these puzzling problems, eventually a solution was found whereby the car's ignition is switched off, the battery is disconnected completely and the battery's harnesses are removed from the battery and bridged together.

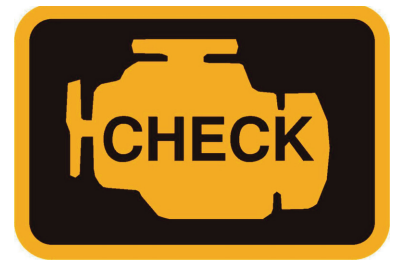
The second vehicle in question was a Fiat Punto Marea, and possibly the Stilo (although I have never encountered the latter personally). The common factor here is that they both share the same Marelli engine ECU. The problem is that the engine management light flashes rapidly, but does not present any serial fault codes and the car drives normally. A rapidly flashing engine management light is somewhat disconcerting for the driver of the vehicle.

The solution to this problem is incredibly simple but without this information, a garage could spend many hours trying to correct the fault. The solution? With the engine running and at operating temperature, the engine must be revved past 4000 RPM before allowing to return rapidly to idle RPM. This process must be conducted four times in order for the light to be put out. Why does this simple procedure work? It resets the crankshaft sensor.
