# Tipp

## A complete solution for Ford Mondeo 1+2!

### Stabilizer mounting repair kit (with clamps) febi 27400

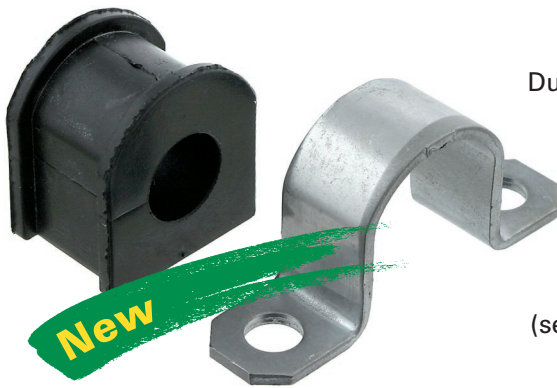
Due to a change of design of the anti roll bar mounting by the car manufacturer, problems occurred when fitting the stabilizer mounting (febi 27355). The former semi-circular design has now been changed to a flat design identical to the original part (see picture 3).

This means the mounting clamp must also be changed. The stabilizer mounts and clamps should always be replaced in pairs to ensure a professional level of servicing.

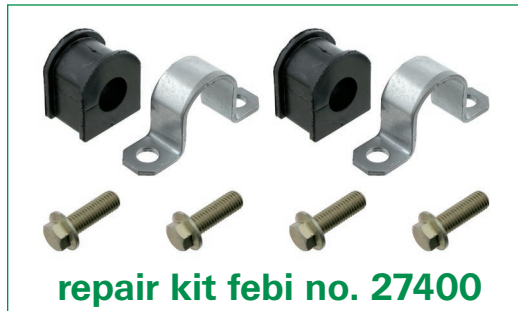
This repair kit contains stabilizer mounts with matching mounting clamps as well as the required high tensile mounting screws (10.9 grade).
