Peugeot 306 1.6 - Braking troubles

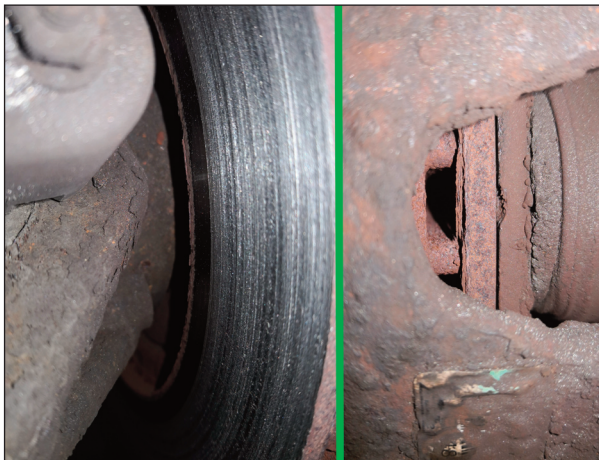
Unfortunately, that ship had sailed and the point at which just a set of brake pads could be fitted had passed. Metal to metal contact had taken place, causing the annoying grinding sound but had designated the brake discs as only good for the scrap metal pile.

Changing the brake pads when the owner had first been warned means the brake discs could have been saved
